This Ole House Home Inspections

Inspection Report

456 Main Street
New Town, NJ

Inspection Date - 11/1/2006

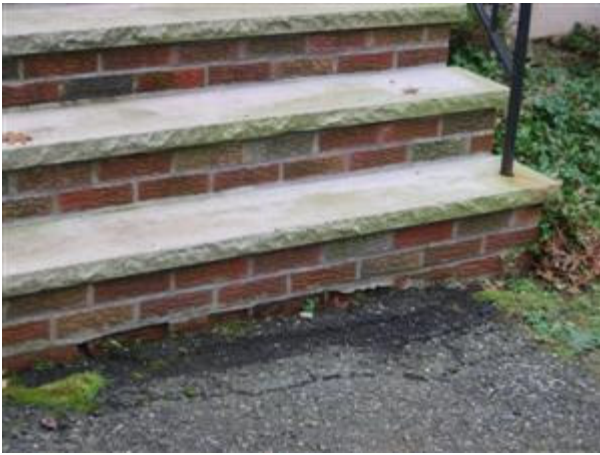
2.4 Picture 1 Left lower stair

2.4 There are two front entrances. The lower stair on the left entrance has a riser of more than 8 inches presenting a tripping hazard. Have the grade at this stair raised to provide an 8 inch riser. The bricks on the right entrance stair are loose and present a safety hazard. The brick work on this porch has deteriorated to the point where the porch should be replaced. Have this porch and entranceway replaced.

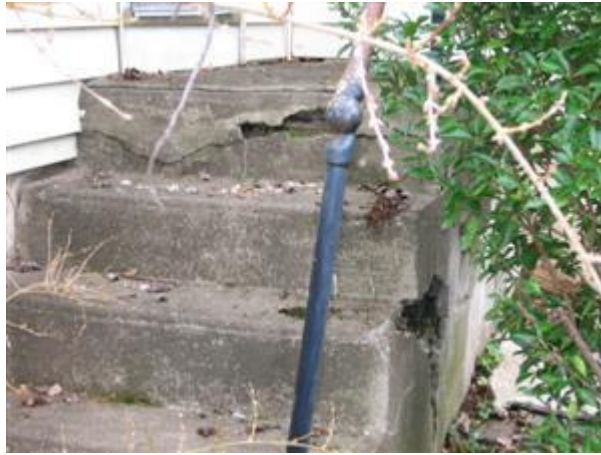
2.4 Picture 4 Rear porch

There is a rear entrance with a masonry porch. This porch has deteriorated to the point where it is unsafe to use. Replace this porch.

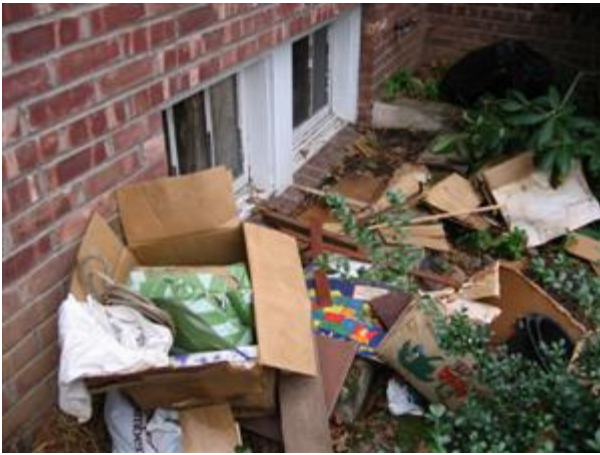
2.5 Picture 1

2.5 The tree limbs that are in contact with roof or hanging near roof should be trimmed.

The masonry window wells are full of debris and leaf fall. This is an attraction to insects and vermin. I recommend that this window wells be replaced with metal units with plastic domes installed. Keep the window wells open and clear.

The asphalt driveway is badly damaged and is beyond repair. This driveway should be replaced.

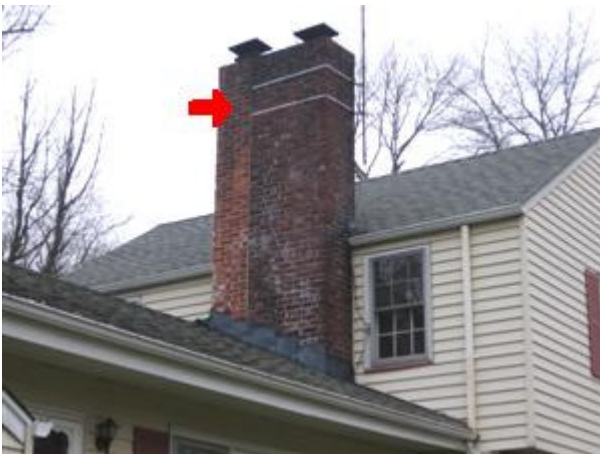
2.6 Picture 1

2.6 There are two chimneys adjacent each other. The visible exterior sections of the chimneys have mechanical damage which if not corrected can lead to internal damage to the chimney(s). The interior components of chimneys are not visible without specialized equipment, and were not inspected. This chimney is more than 20 years old. The National Fire Protection Association and the National Chimney Sweep Guild recommend that chimneys more than 20 years old be given a level 2-chimney inspection to rule out hidden safety defects. I recommend you have the mechanical damage repaired, the chimney flues cleaned and a level 2-chimney inspection performed.

There is an antennae mounted on one of the chimneys. Chimneys are not designed to carry the weight of foreign objects like antennas and can be damaged by antennas and the mounting equipment. This equipment should be removed from the chimney. In addition the second chimney was constructed with the antennae still mounted on the first. When the antennae is removed, The mortar between the two chimneys may be damaged. Be sure that this mortar is repaired.

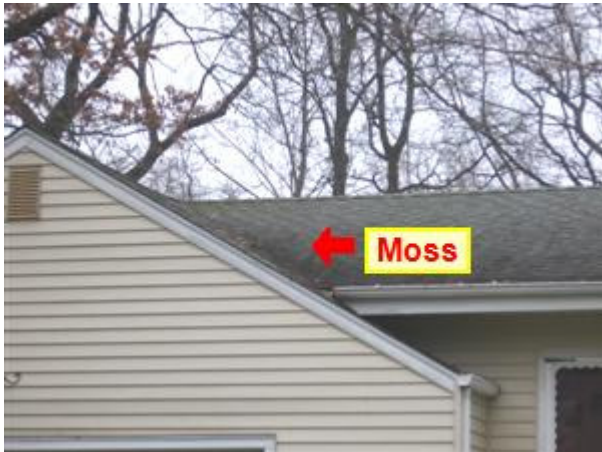
4.1 Picture 1

4.1 The roof has accumulated moss on the side that is not washed by sunlight. The overgrown tree adjacent to this area that shades the roof and contributes to the moss growth. The attic space under this area was not accessible and could not be observed. I recommend that a qualified roofing contractor repair this section of roof and inspect the remaining roof and flashings. Follow the advice given.

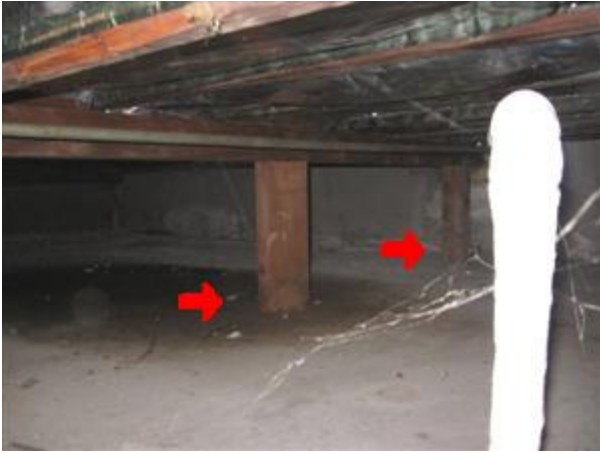
5.2 Picture 1 Temporary columns

5.2 The structure above the right front crawlspace is supported by 4 X 4 beams on temporary wood columns that are not sitting on proper footings. This section of the home has inadequate support and can be unsafe. I recommend that these columns be placed on proper footings.

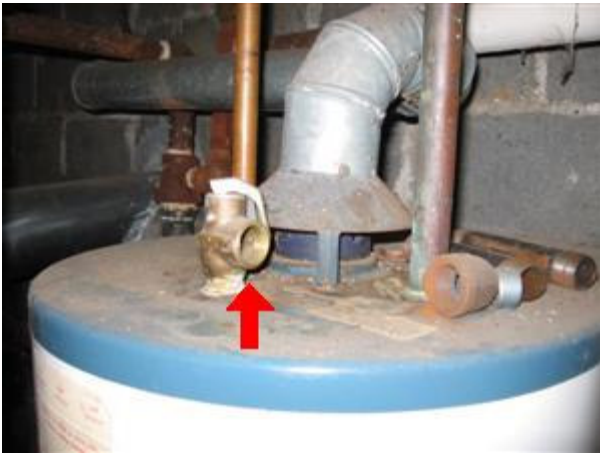
8.4 Picture 1

8.4 The water heater is more than 10 years old. Units of this type have an expected service life of approximately 10 years depending on maintenance. I recommend that you budget to replace this unit soon.

The TPR (Temperature Pressure Relief) valve on the water heater does not have an extension that reaches to within 6 inches of the floor. This is a scalding hazard. Until the unit is replaced, I recommend that a 3/4 inch unthreaded metal pipe that extends to within 6 inches of floor be installed.

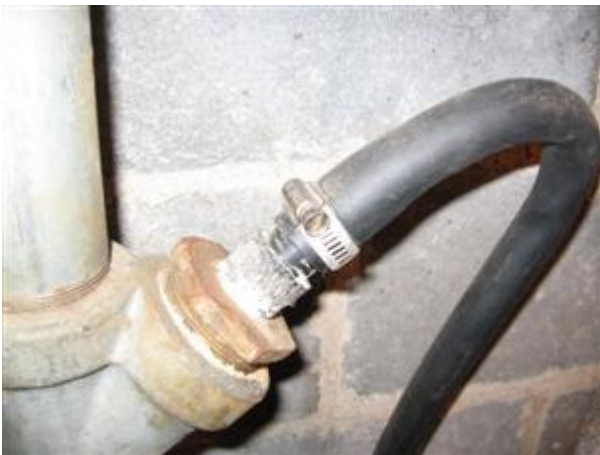
8.7 Picture 1 Washer drain

8.7 The washing machine drain hose is plumbed directly into the waste line. This condition can permit sewerage to back up into the washer. The drain hose should be emptying into a drain and a trap greater than 2 inches.

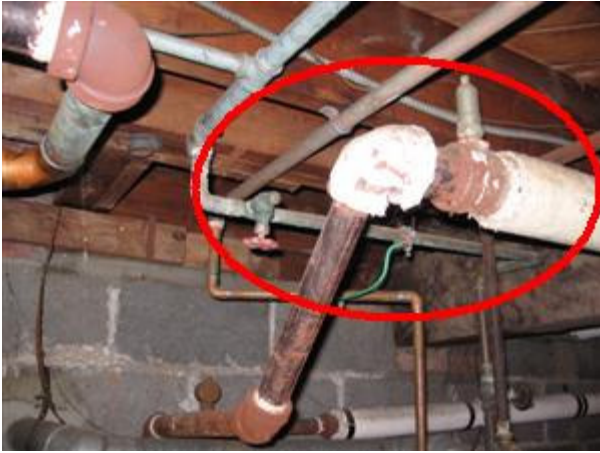
13.5 Picture 1 Heating pipes

13.5 This inspection cannot guarantee that asbestos materials, which have been commonly used for insulation and some finish material, are present or absent from this home. Older homes usually have some asbestos building materials used in the construction, while more recently constructed homes are likely to have little or none. I DID observe evidence asbestos like material used for for insulation on the heating pipes and on the oven vent pipe in the home. Breathing asbestos can be a health hazard. I recommend you contact a private firm licensed to test for asbestos hazards and remediate as necessary.
